## MOISTURE & MOULD TECHNICAL INSPECTION REPORT

Mould Removal Services Ireland – Part of Causeway Cleaning Group

**SAMPLE & DEMONSTRATION REPORT — FOR MARKETING USE ONLY**

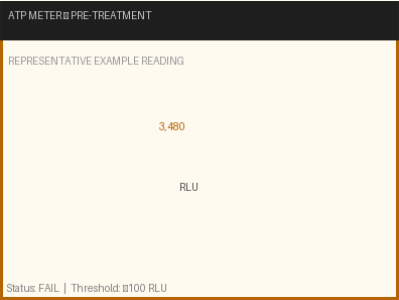
ATP Meter — Pre-Treatment Representative: 3,480 RLU (FAIL) Confirms elevated surface biological contamination

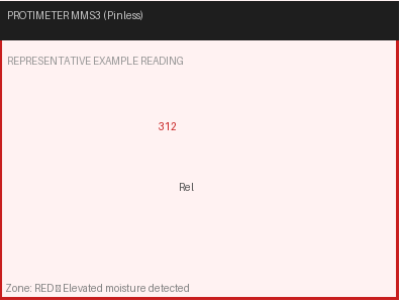
Protimeter MMS3 — Pinless Mode Representative: 312 Rel (Red zone — elevated moisture confirmed)

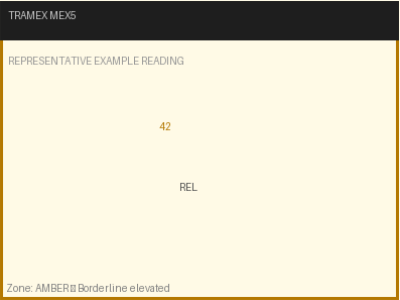
Tramex MEX5 Masonry Meter Representative: 42 REL (Amber zone — borderline/elevated)

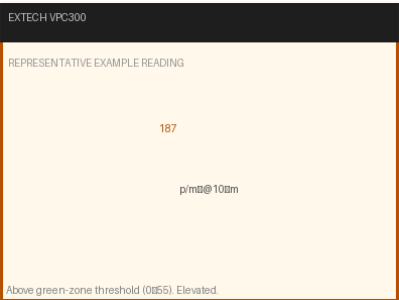
Extech VPC300 Particle Counter Representative: 187 p/m³ @ 10µm (Above green zone threshold of 55)

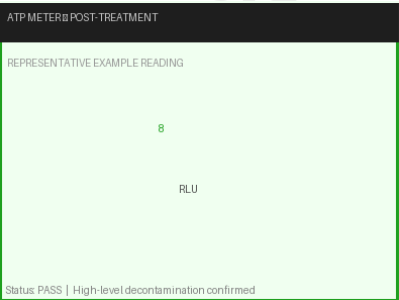
ATP Meter — Post-Treatment Representative: 8 RLU (PASS — Excellent) 100% reduction confirmed

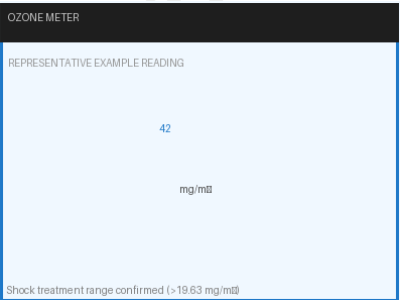
Ozone Concentration Meter Representative: 42 mg/m³ (Shock treatment range — professional grade)

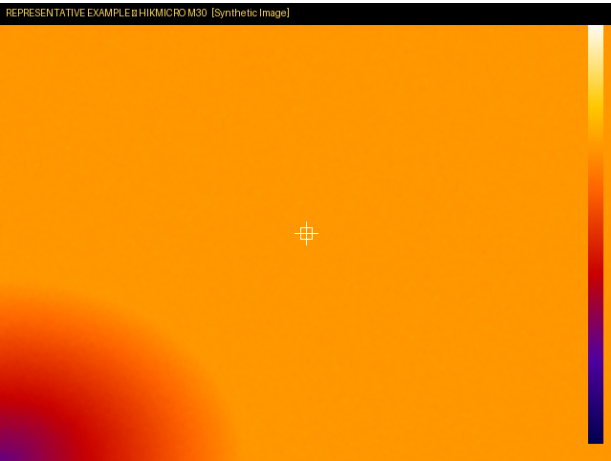
Bedroom 1 — N/W corner junction Cold zone at floor-wall-ceiling intersection (Synthetic illustration — representative pattern)

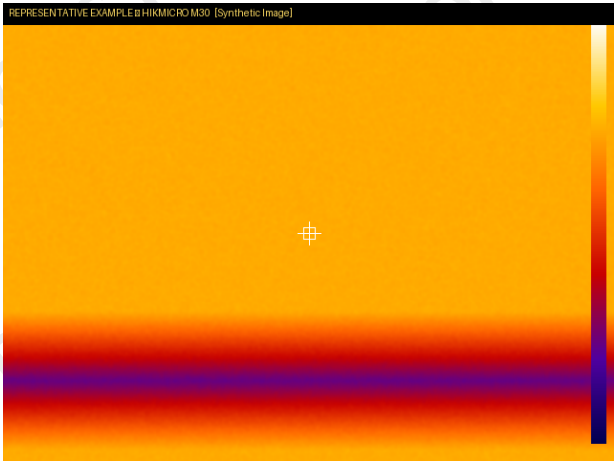
Bedroom 1 — External wall base Cold bridge along lower horizontal zone (Synthetic illustration — representative pattern)

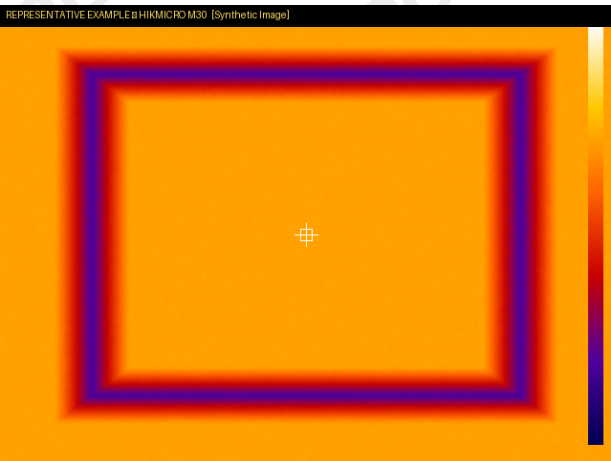
Living Room — Window reveal Cold bridging around window frame perimeter (Synthetic illustration — representative pattern)

Replace single-glazed windows with double-glazed uPVC or thermally-broken aluminium units with trickle vents. Trickle vents will also provide background ventilation currently absent from the property.

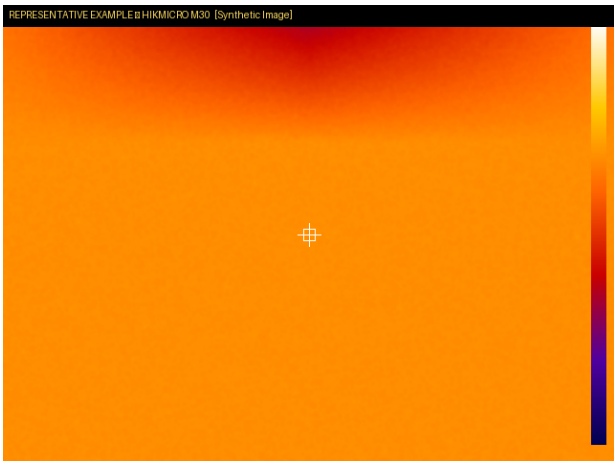
Bathroom — Ceiling junction Cold zone at wall-ceiling structural junction (Synthetic illustration — representative pattern)

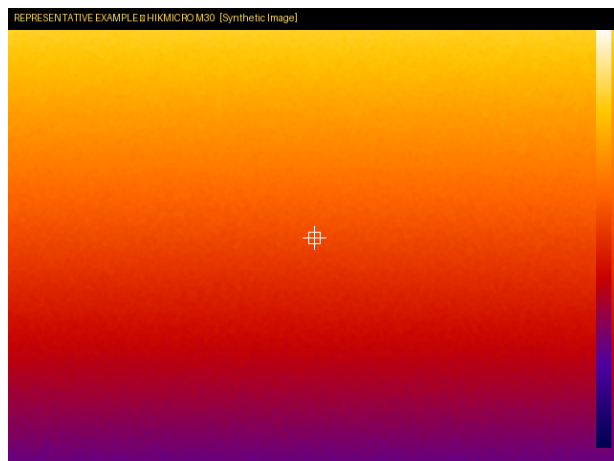
External wall — Temperature gradient Warm-to-cold gradient across wall fabric (Synthetic illustration — representative pattern)

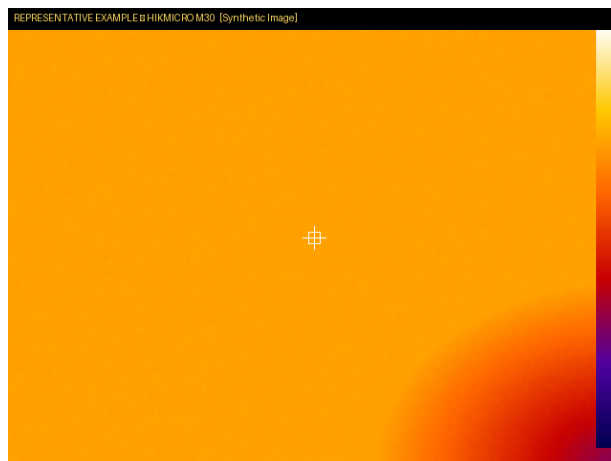
Bedroom 2 — S/E corner Cold zone at corner junction (Synthetic illustration — representative pattern)

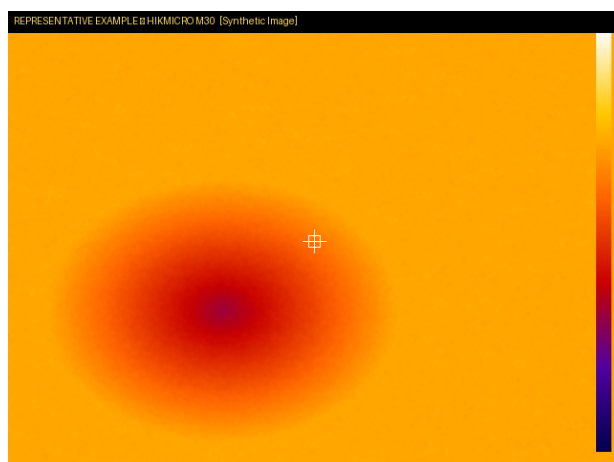
Living Room — Cold patch mid-wall Localised cold area behind thermal bridge (Synthetic illustration — representative pattern)

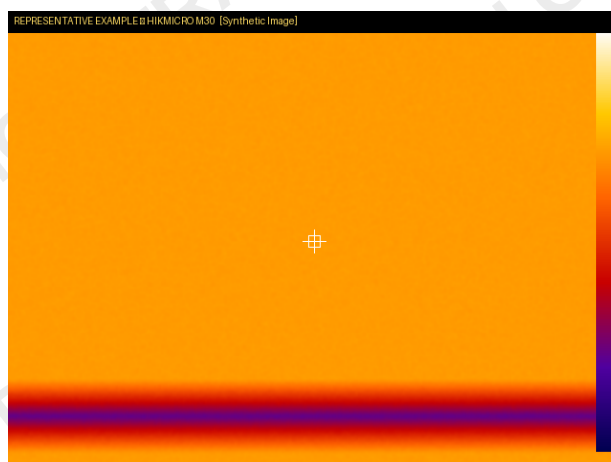
Kitchen — Floor-wall junction Cold bridge at floor zone (Synthetic illustration — representative pattern)
